Description

IP65, Class I. Class II on request. IK07. Marine-grade, die-cast aluminium alloy. 5CE superior corrosion protection including PCS hardware. Silicone CCG® Controlled Compression Gasket. Safety glass lens. Two cable entries. Integral EC electronic converter. CAD-optimised optics for superior illumination and glare control. OLC® One LED Concept. Factory installed LED circuit board. 1-10V or DALI interface on request. Optional 2200 K version available. To be specified at time of ordering.

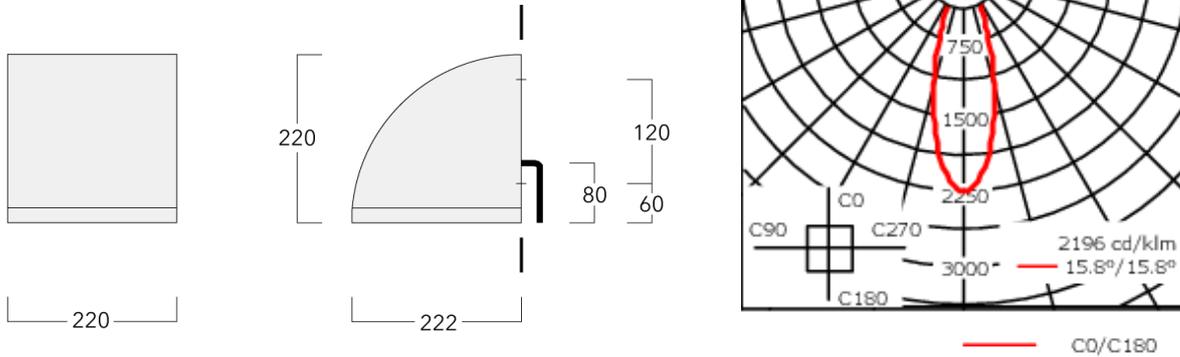
Weight	6.60 kg
Light distribution	symmetric, medium beam [M]
Light source	LED-12/12W / 350 mA - 2700 K
CRI	80
Power supply	EC
LEDs	12
Rated input power	13.9 W
Nominal Lumen (lm)	
LED Lumen	145
Total Lumen	1740
T _j	85
Rated lumens (lm)	
LED Lumen	124.9
Total Lumen	1499.3
T _a	25
