Description

IP65, Class I. Class II on request. IK07. Marine-grade, die-cast aluminium alloy. 5CE superior corrosion protection including PCS hardware. Silicone CCG® Controlled Compression Gasket. Safety glass lens. Two cable entries. Integral EC electronic converter. CAD-optimised optics for superior illumination and glare control. OLC® One LED Concept. Factory installed LED circuit board. 1-10V or DALI interface on request. Optional 2200 K version available. To be specified at time of ordering.

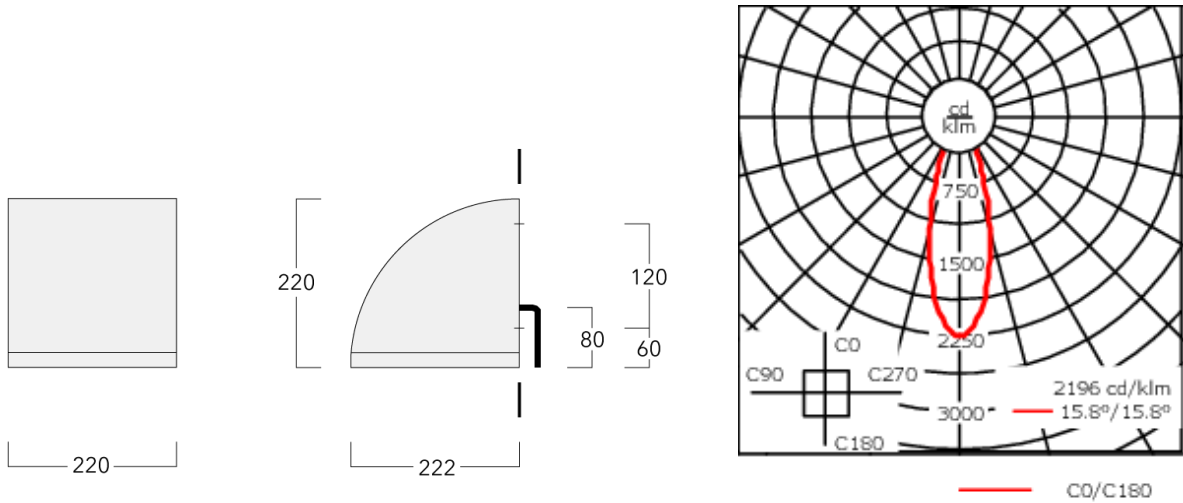
Weight	6.60 kg
Light distribution	symmetric, medium beam [M]
Light source	LED-12/18W / 500 mA - 2700 K
CRI	80
Power supply	EC
LEDs	12
Rated input power	21 W
Nominal Lumen (lm)	
LED Lumen	200
Total Lumen	2400
Tj	85
Rated lumens (lm)	
LED Lumen	172.3
Total Lumen	2068
Ta	25
