Description

IP65, Class I. Class II on request. IK07. Marine-grade, die-cast aluminium alloy. 5CE superior corrosion protection including PCS hardware. Silicone CCG® Controlled Compression Gasket. Safety glass lens. Two cable entries. Integral EC electronic converter. CAD-optimised optics for superior illumination and glare control. OLC® One LED Concept. Factory installed LED circuit board. 1-10V or DALI interface on request. Optional 2200 K version available. To be specified at time of ordering.

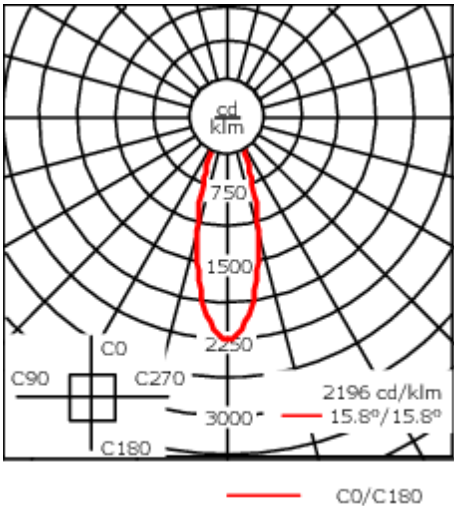
Can be mounted up or down.

Weight	6.60 kg
Light distribution	symmetric, medium beam [M]
Light source	LED-12/18W / 500 mA - 2700 K
CRI	80
Power supply	EC
LEDs	12
Rated input power	21 W
