Description

WE-EF LEUCHTEN GmbH

132-0636

OLV330 LED

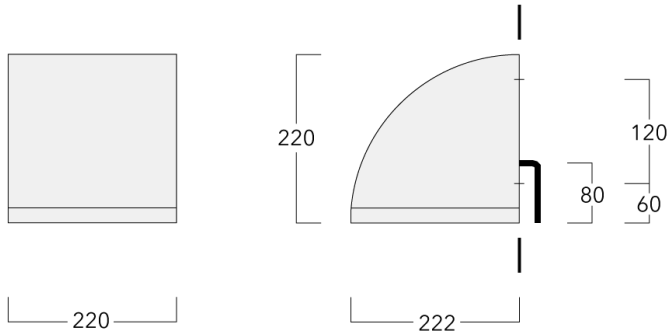
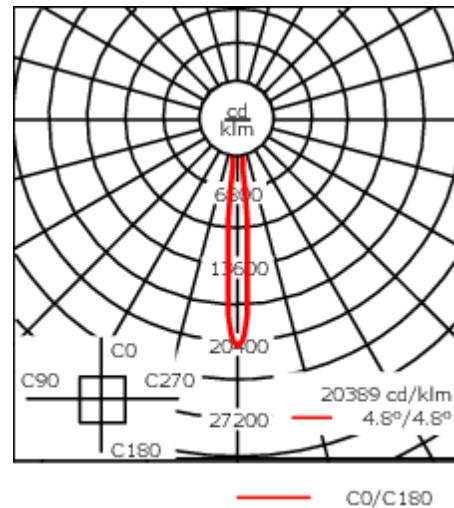
Can be mounted up or down.

Weight	6.60 kg
Light distribution	symmetric, very narrow beam, sharp cut-off [EES]
Light source	LED-12/18W / 500 mA - 2700 K
CRI	80
Power supply	EC
LEDs	12
Rated input power	21 W
Nominal Lumen (lm)	
LED Lumen	200
Total Lumen	2400
T _j	85
Rated lumens (lm)	
LED Lumen	176.9
Total Lumen	2122.7
T _a	25
