Description

IP65, Class I. Class II on request. IK07. Marine-grade, die-cast aluminium alloy. 5CE superior corrosion protection including PCS hardware. Silicone CCG® Controlled Compression Gasket. Safety glass lens. Two cable entries. Integral EC electronic converter. CAD-optimised optics for superior illumination and glare control. OLC® One LED Concept. Factory installed LED circuit board. 1-10V or DALI interface on request. Optional 2200 K version available. To be specified at time of ordering.

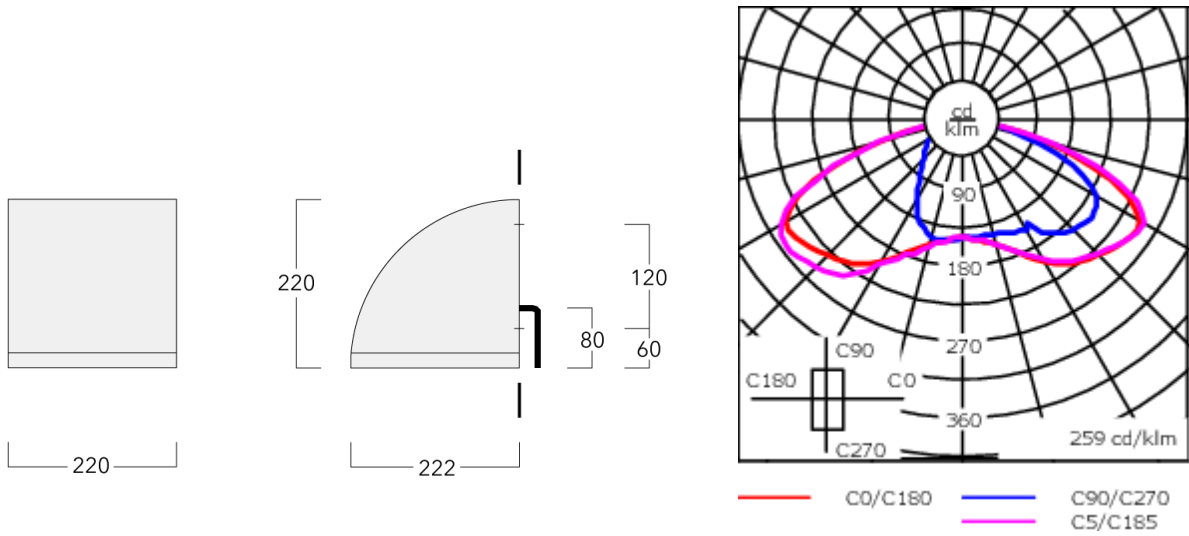
Can be mounted up or down.

Weight	6.60 kg
Light distribution	rectangular, side throw [R65]
Light source	LED-12/12W / 350 mA - 2700 K
CRI	80
Power supply	EC
LEDs	12
Rated input power	13.9 W
