Description

IP65, Class I. Class II on request. IK07. Marine-grade, die-cast aluminium alloy. 5CE superior corrosion protection including PCS hardware. Silicone CCG® Controlled Compression Gasket. Safety glass lens. Two cable entries. Integral EC electronic converter. CAD-optimised optics for superior illumination and glare control. OLC® One LED Concept. Factory installed LED circuit board. 1-10V or DALI interface on request. Optional 2200 K version available. To be specified at time of ordering.

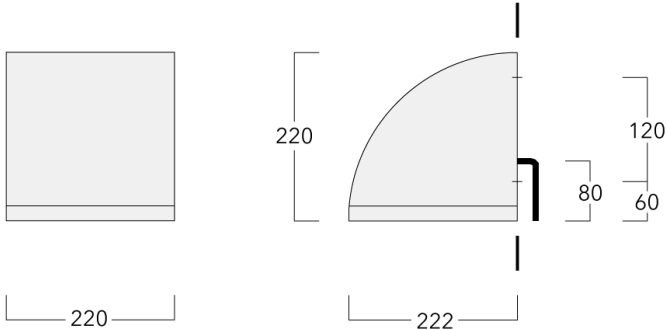
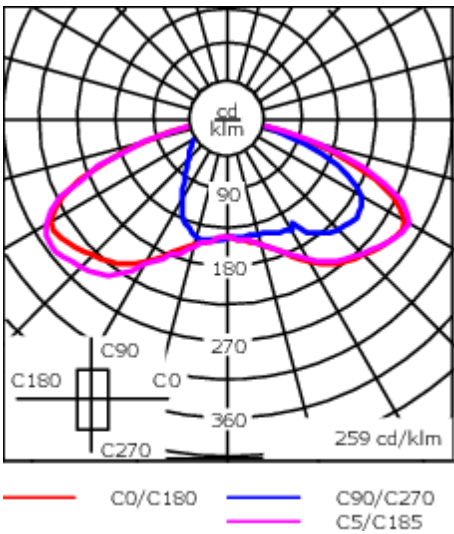
Can be mounted up or down.

Weight	6.60 kg
Light distribution	rectangular, side throw [R65]
Light source	LED-12/12W / 350 mA - 2700 K
CRI	80
Power supply	EC
LEDs	12
Rated input power	13.9 W
