Description

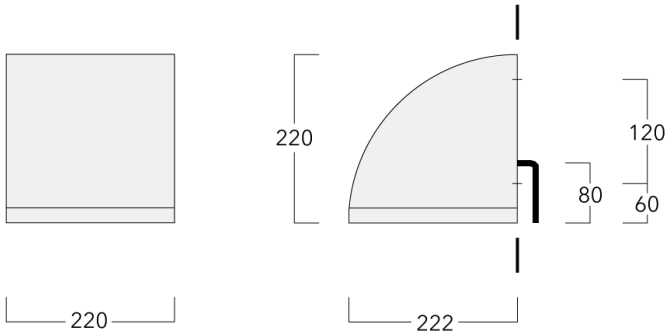
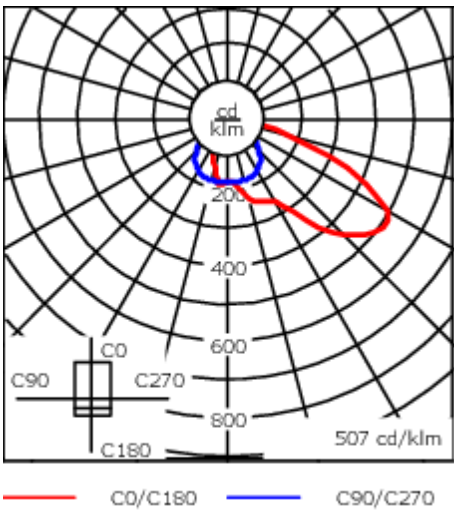
Weight	6.60 kg
Light distribution	asymmetric, forward throw [A60]
Light source	LED-12/24W / 700 mA - 2700 K
CRI	80
Power supply	EC
LEDs	12
Rated input power	27 W

Nominal Lumen (lm)	
LED Lumen	270
Total Lumen	3240
Tj	85

Rated lumens (lm)	
LED Lumen	204.1
Total Lumen	2449.2
Ta	25
