Description

IP65, Class I. Class II on request. IK07. Marine-grade, die-cast aluminium alloy. 5CE superior corrosion protection including PCS hardware. Silicone CCG® Controlled Compression Gasket. Safety glass lens. Two cable entries. Integral EC electronic converter. CAD-optimised optics for superior illumination and glare control. OLC® One LED Concept. Factory installed LED circuit board. 1-10V or DALI interface on request. Optional 2200 K version available. To be specified at time of ordering.

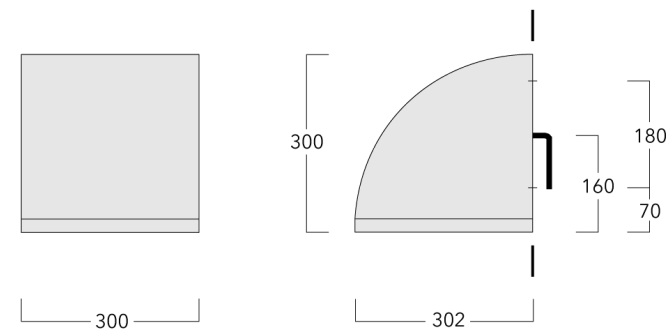
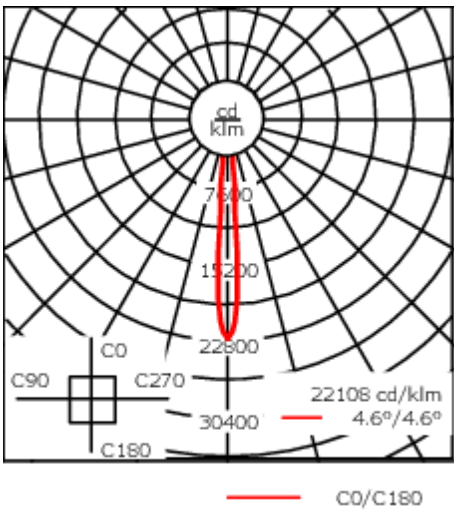
Weight	11.40 kg
Light distribution	symmetric, very narrow beam, sharp cut-off [EES]
Light source	LED-24/24W / 350 mA - 2700 K
CRI	80
Power supply	EC
LEDs	24
Rated input power	26.5 W
