Description

IP65, Class I. Class II on request. IK07. Marine-grade, die-cast aluminium alloy. 5CE superior corrosion protection including PCS hardware. Silicone CCG® Controlled Compression Gasket. Safety glass lens. Two cable entries. Integral EC electronic converter. CAD-optimised optics for superior illumination and glare control. OLC® One LED Concept. Factory installed LED circuit board. 1-10V or DALI interface on request. Optional 2200 K version available. To be specified at time of ordering.

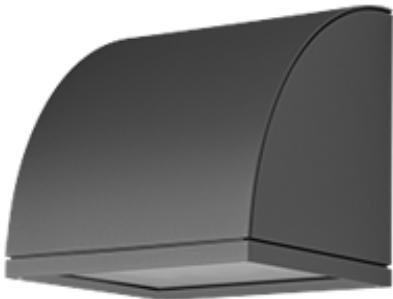
Can be mounted up or down.

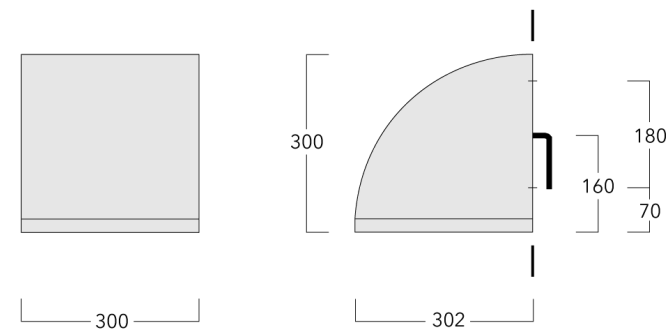
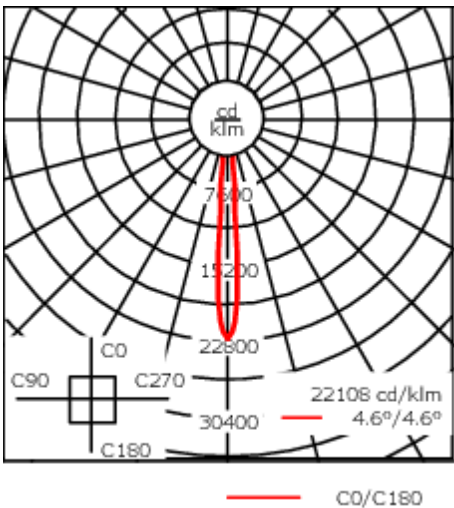
Weight	11.40 kg
Light distribution	symmetric, very narrow beam, sharp cut-off [EES]
Light source	LED-24/36W / 500 mA - 2700K
CRI	80
Power supply	EC
LEDs	24
Rated input power	39 W
