Description

IP65, Class I. Class II on request. IK07. Marine-grade, die-cast aluminium alloy. 5CE superior corrosion protection including PCS hardware. Silicone CCG® Controlled Compression Gasket. Safety glass lens. Two cable entries. Integral EC electronic converter. CAD-optimised optics for superior illumination and glare control. OLC® One LED Concept. Factory installed LED circuit board. 1-10V or DALI interface on request. Optional 2200 K version available. To be specified at time of ordering.

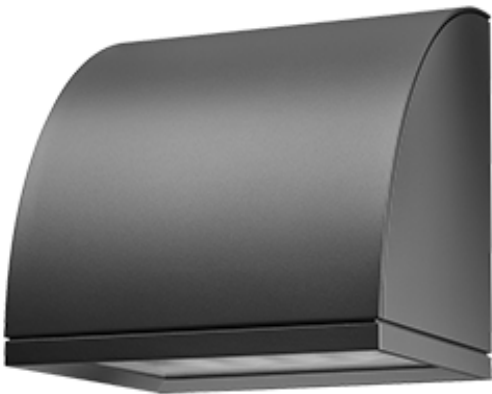
Can be mounted up or down.
