Description

IP65, Class I. Class II on request. IK07. Marine-grade, die-cast aluminium alloy. 5CE superior corrosion protection including PCS hardware. Silicone CCG® Controlled Compression Gasket. Safety glass lens. Two cable entries. Integral EC electronic converter. CAD-optimised optics for superior illumination and glare control. OLC® One LED Concept. Factory installed LED circuit board. 1-10V or DALI interface on request. Optional 2200 K version available. To be specified at time of ordering.

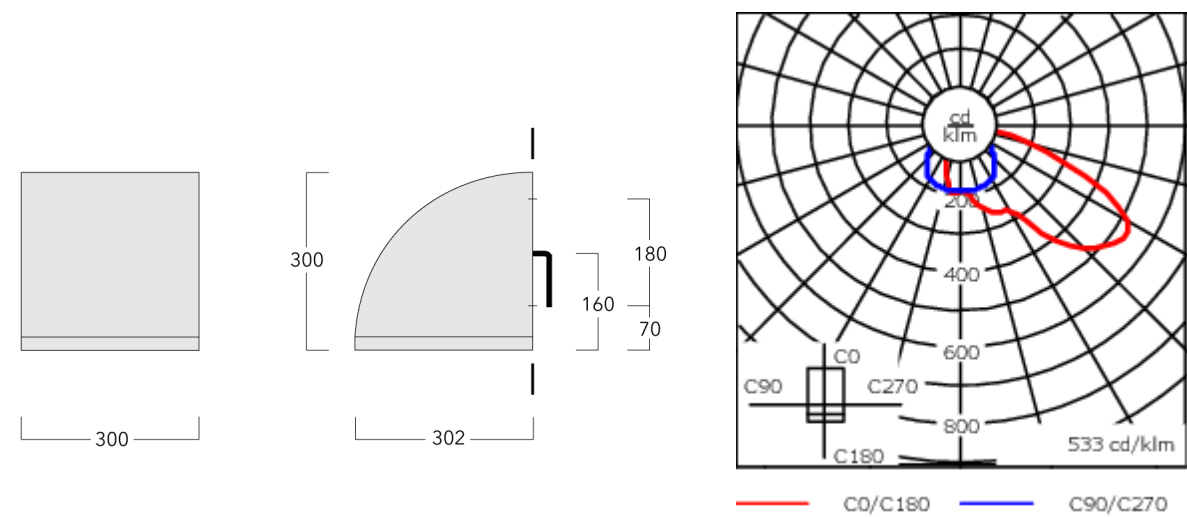
Weight	11.40 kg
Light distribution	asymmetric, forward throw [A60]
Light source	LED-24/24W / 350 mA - 2700 K
CRI	80
Power supply	EC
LEDs	24
Rated input power	26.5 W
