Description

IP65, Class I. Class II on request. IK07. Marine-grade, die-cast aluminium alloy. 5CE superior corrosion protection including PCS hardware. Silicone CCG® Controlled Compression Gasket. Safety glass lens. Two cable entries. Integral EC electronic converter. CAD-optimised optics for superior illumination and glare control. OLC® One LED Concept. Factory installed LED circuit board. 1-10V or DALI interface on request. Optional 2200 K version available. To be specified at time of ordering.

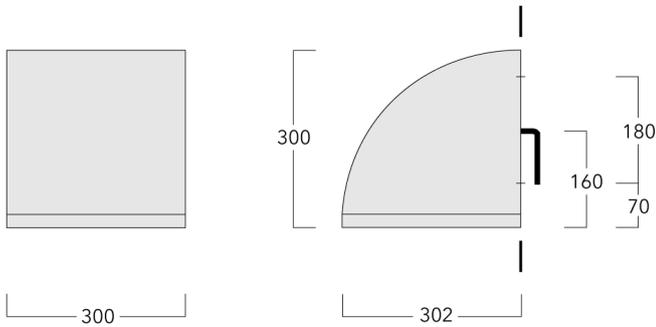
Weight	11.40 kg
Light distribution	asymmetric, forward throw [A60]
Light source	LED-24/48W / 700 mA - 2700 K
CRI	80
Power supply	EC
LEDs	24
Rated input power	54 W
Nominal Lumen (lm)	
LED Lumen	270
Total Lumen	6480
T _j	85
Rated lumens (lm)	
LED Lumen	204.1
Total Lumen	4898.3
T _a	25
