Description

IP65, Class I. Class II on request. IK07. Marine-grade, die-cast aluminium alloy. 5CE superior corrosion protection including PCS hardware. Silicone CCG® Controlled Compression Gasket. Safety glass lens. Two cable entries. Integral EC electronic converter. CAD-optimised optics for superior illumination and glare control. OLC® One LED Concept. Factory installed LED circuit board. 1-10V or DALI interface on request. Optional 2200 K version available. To be specified at time of ordering.

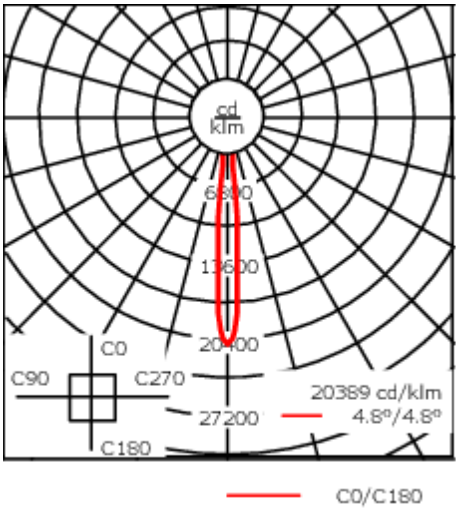
Can be mounted up or down.

Weight	6.60 kg
Light distribution	symmetric, very narrow beam, sharp cut-off [EES]
Light source	LED-12/18W / 500 mA - 4000 K
CRI	80
Power supply	EC
LEDs	12
Rated input power	21 W
