Description

Weight	6.60 kg
Light distribution	asymmetric, side throw [S70]
Light source	LED-12/24W / 700 mA - 3000 K
CRI	80
Power supply	EC
LEDs	12
Rated input power	27 W

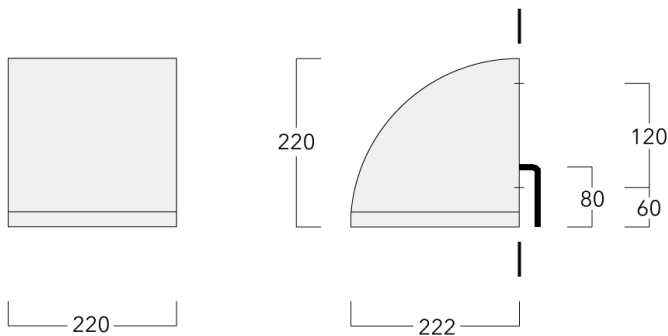
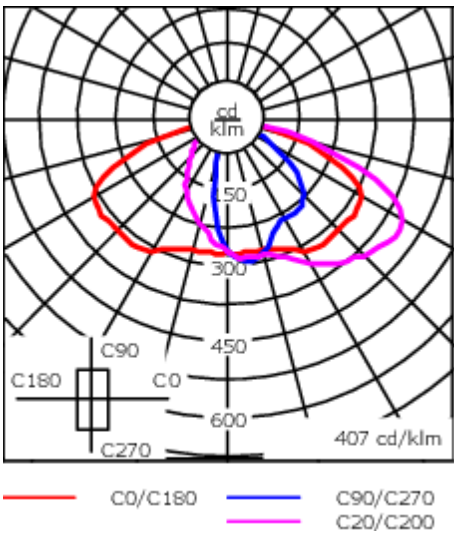
IP65, Class I. Class II on request. IK07. Marine-grade, die-cast aluminium alloy. 5CE superior corrosion protection including PCS hardware. Silicone CCG® Controlled Compression Gasket. Safety glass lens. Two cable entries. Integral EC electronic converter. CAD-optimised optics for superior illumination and glare control. OLC® One LED Concept. Factory installed LED circuit board. 1-10V or DALI interface on request. Optional 2200 K version available. To be specified at time of ordering.
