Description

IP65, Class I. Class II on request. IK07. Marine-grade, die-cast aluminium alloy. 5CE superior corrosion protection including PCS hardware. Silicone CCG® Controlled Compression Gasket. Safety glass lens. Two cable entries. Integral EC electronic converter. CAD-optimised optics for superior illumination and glare control. OLC® One LED Concept. Factory installed LED circuit board. 1-10V or DALI interface on request. Optional 2200 K version available. To be specified at time of ordering.

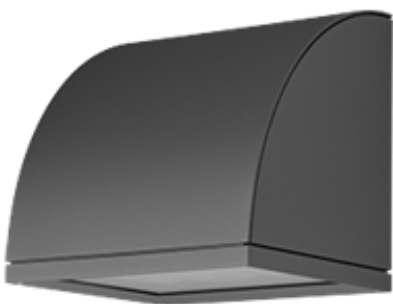
Can be mounted up or down.

Weight	11.40 kg
Light distribution	symmetric, very narrow beam, sharp cut-off [EES]
Light source	LED-24/24W / 350 mA - 3000 K
CRI	80
Power supply	EC
LEDs	24
Rated input power	26.5 W

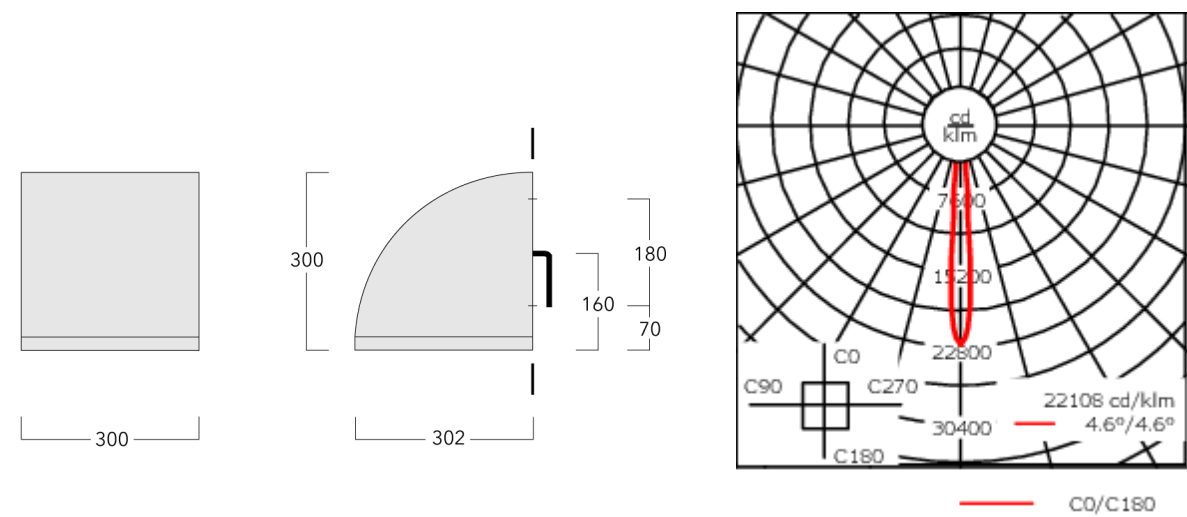
Nominal Lumen (lm)	
LED Lumen	155
Total Lumen	3720
Tj	85

Rated lumens (lm)	
LED Lumen	143.5
Total Lumen	3443.5
Ta	25
