Description

IP65, Class I. Class II on request. IK07. Marine-grade, die-cast aluminium alloy. 5CE superior corrosion protection including PCS hardware. Silicone CCG® Controlled Compression Gasket. Safety glass lens. Two cable entries. Integral EC electronic converter. CAD-optimised optics for superior illumination and glare control. OLC® One LED Concept. Factory installed LED circuit board. 1-10V or DALI interface on request. Optional 2200 K version available. To be specified at time of ordering.

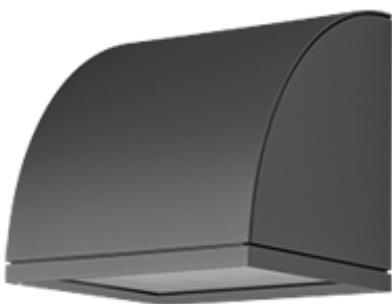
Can be mounted up or down.

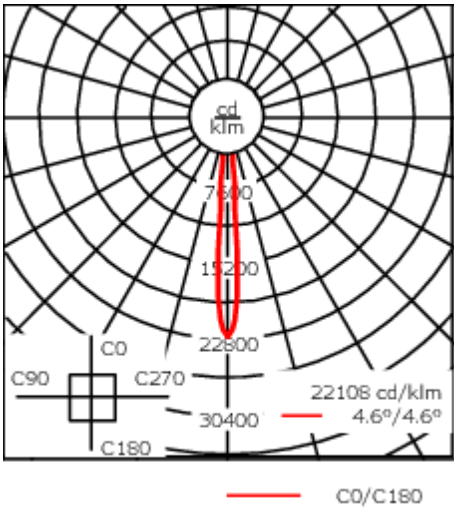
Weight	11.40 kg
Light distribution	symmetric, very narrow beam, sharp cut-off [EES]
Light source	LED-24/24W / 350 mA - 4000 K
CRI	80
Power supply	EC
LEDs	24
Rated input power	26.5 W
